**BRIDGETON TOWNSHIP DELAWARE RIVER
STREAMBANK EROSION STUDY
November 2020**

Prepared by: Rippled Waters Engineering, LLC

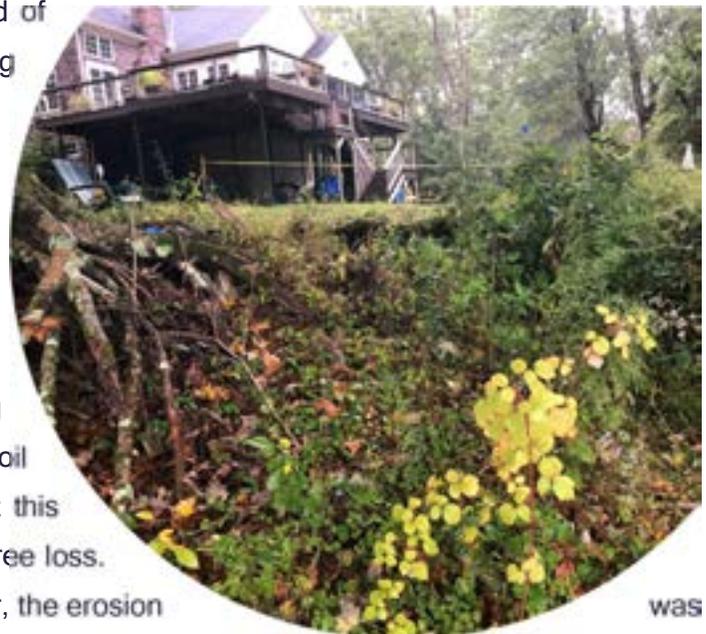
At the terminus of Trails End Lane (in the yard of house number 1870) is a sinkhole forming adjacent to the bank of the Delaware River. The sinkhole is approximately 240 feet south of the High Falls Creek confluence. Along with a concrete pad on the downstream side of the confluence that is accumulating woody debris these conditions could produce a local eddy causing erosion. The bank is experiencing planar erosion which has created a void in the soil profile inducing cavitation. Continued failure at this site would lead to property loss and potential tree loss.

The streambanks in AOC#1 is eroding, however, the erosion

RWE recommends this technique be considered for AOC#1, AOC#2 and AOC#5. In these locations, VMSE walls may be suitable as there is sufficient area to construct this type of technique and the technique will provide long-term stabilization.

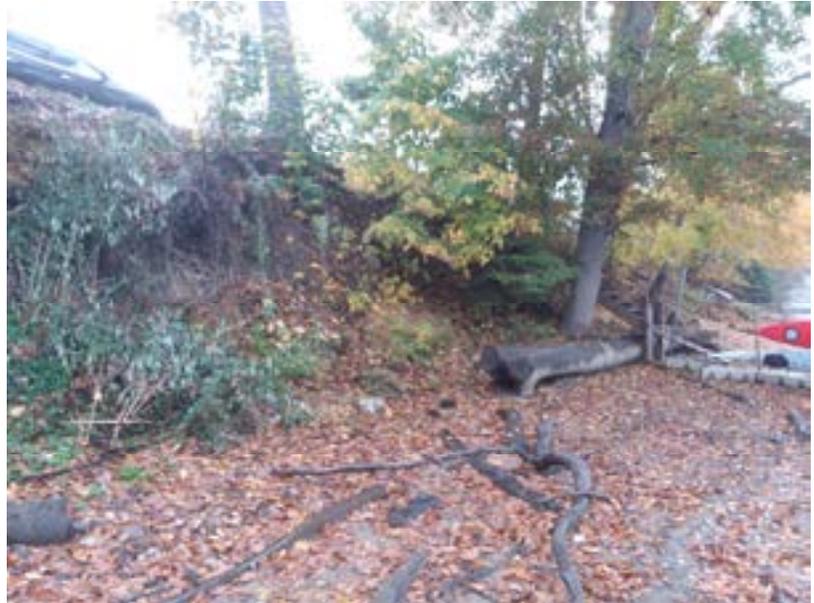
A portion of the streambank extending for a length of 90 feet is eroding in close proximity to the travel lane of Trails End Lane. AOC#2 is located across the street from 1810 Trails End Lane. High flows from the Delaware River continue to erode this bank as steep unvegetated slopes (~3H:1V) were noted. Tree fall has weakened past attempts at bank stabilization and further soil loss can be expected due to the active erosion at the site. A large log running beneath an existing staircase and parallel to the bank may be exacerbating local erosion by inadvertently directing the stream flows into the bank. Nearby hardscaping is beginning to slide down the bank as a result of the erosion as well. Further erosion at this site may ultimately erode the active travelway of Trails End Lane.

RWE collected measurements of the embankment at AOC#2 and developed typical cross-section A-A' of the streambank. The cross-section details the slopes of the bank from the edge of water at the Delaware River up to the top of the embankment along the roadway, and the cross-sections are shown on the map included in Appendix A.

RWE does not recommend the use of gabion baskets except potentially at AOC#2. This would need to be carefully reviewed before being implemented as it relates to velocities and shear stresses within the Delaware before proceeding.

RWE recommends that retaining walls be considered for AOC#2 and AOC#6 if needed. It can be costly to design and permit this solution, however, it may be the only viable option in areas where there is limited work area to construct other measures.

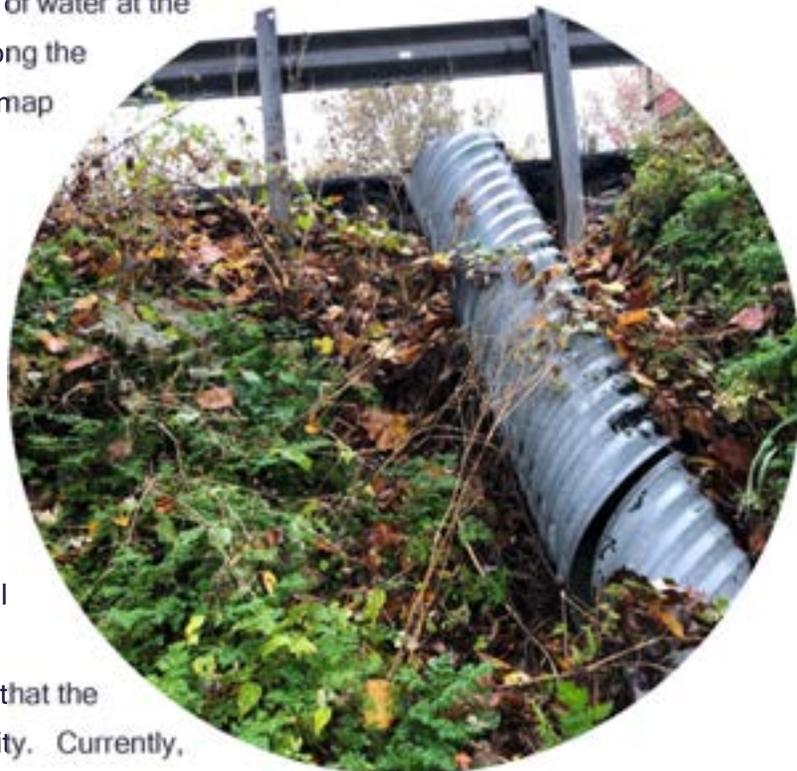
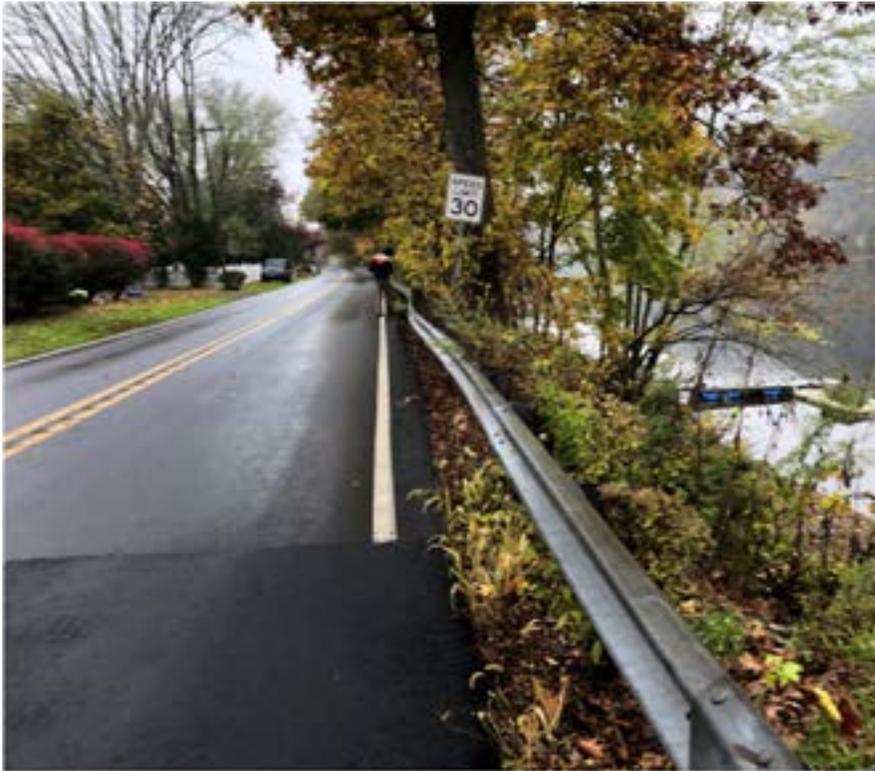
Across from Riverview Antiques along River Road, there is a 15" diameter cast iron stormwater outfall pipe inside a corrugated metal sleeve. It appears that the sleeve was intended to direct the runoff from the pipe to the bottom of the streambank. The top of the sleeve extends above the pavement surface, so the water itself no longer enters the pipe from the pavement itself. The condition of the outfall pipe was difficult to view given its location within the corrugated metal pipe, however, it can be assumed that the sleeve was also installed to protect the pipe's integrity. Currently,

stormwater runoff is eroding the soil in and around the corrugated pipe back migrating upwards from the bottom of the sleeve towards the road. This erosion has exposed the guardrail I-beams. As erosion continues the structural integrity of the guardrail and the pavement may become compromised.

RWE recommends the use of this technique at AOC#3. This will address the erosion in and around the existing outfall pipe.

- AOC#3 - A drop manhole structure is recommended. This pipe is undersized and not placed appropriately to capture the runoff from the roadway.
- AOC#4 - This area

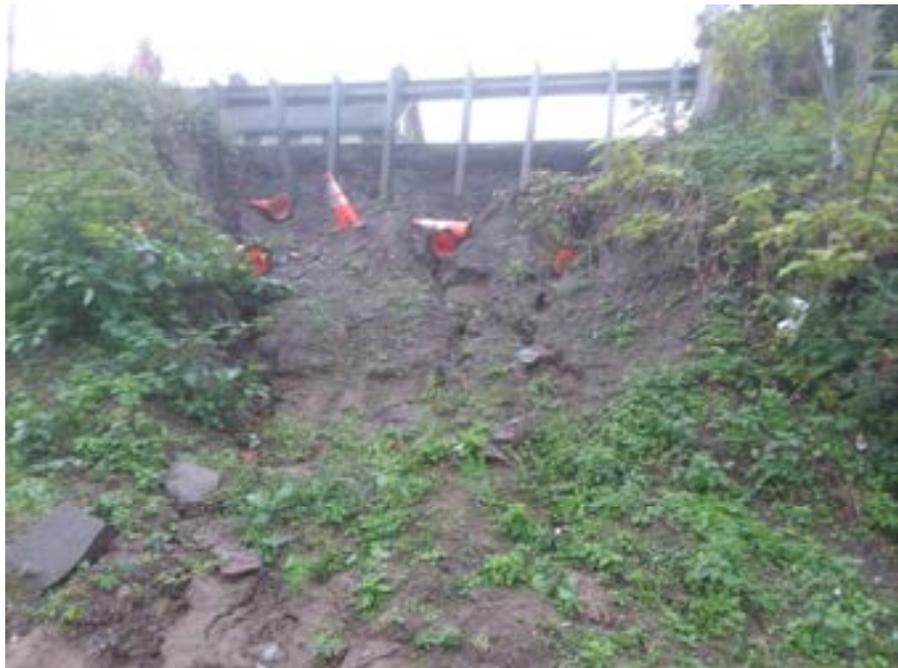
Just north of the Upper Black Eddy/Milford bridge there is significant streambank erosion extending for a length of ~175 feet. This erosion is caused by a combination of the flows in the river together with local stormwater runoff erosion. An existing stormwater pipe crossing under River Road is nearly level with the guardrail I-beams. The proximity of the

stormwater outfall discharge to the roadway elevation without the presence of conduit outlet protection is causing severe erosion in this location. The erosion has continued to a point where several of the guardrail beams are completely exposed. The location of this erosion is also such that it is at a point where the cross-section of the Delaware River is narrower. This results in increased near bank erosion and shear stresses acting on the streambank. The erosion has progressed to a point where it is going to cause collapse of River Road and without remediation significant road damage is to be expected. Typical Cross-Section B-B' is included in Appendix A.

RWE recommends this technique be considered for AOC#5. In this location, a timber crib wall may be suitable and will provide long-term stabilization.

RWE recommends this technique be considered for AOC#5. In this location, half dense riprap may be suitable and will provide long-term stabilization.

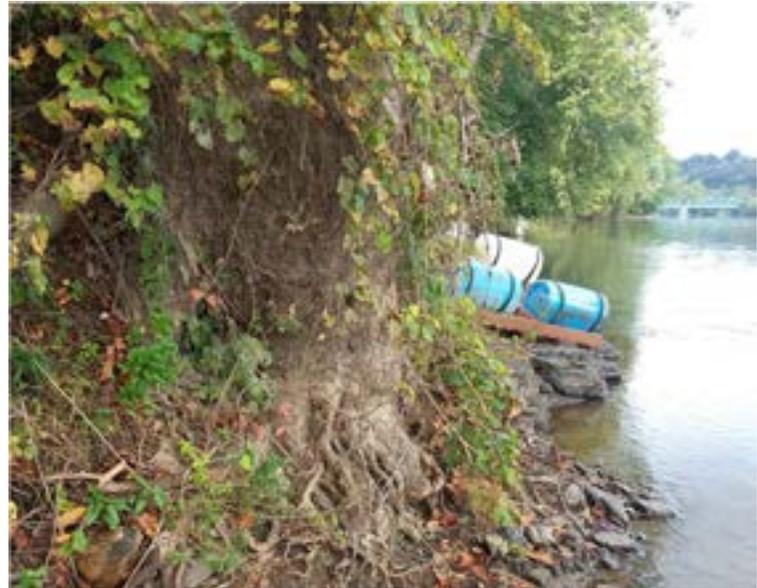
At AOC#6, there is an extensive area of exposed bedrock at the bottom of the bank. The banks in this area were observed to have near vertical slopes in several locations and are only a few feet from impacting the active travelway of River Road. The length of this area of the streambank extends for 1,800 feet, however, erosion of the banks is intermittent and is estimated to be less than 300 linear feet in total. Tree fall may

result in significant sloughing of the streambank could cause detrimental impacts to the roadway. Eddies are forming along the edge of the pavement where concentrated street flow is collecting in low lying depressions. This stormwater pooling will likely promote additional tree fall in the area and could result in increased erosion of the overall bank given its vertical configuration.

RWE recommends this technique be considered for AOC#4, AOC#6 and AOC#7. There appears to be room to install swales to collect runoff and convey them to existing outfalls in this region,

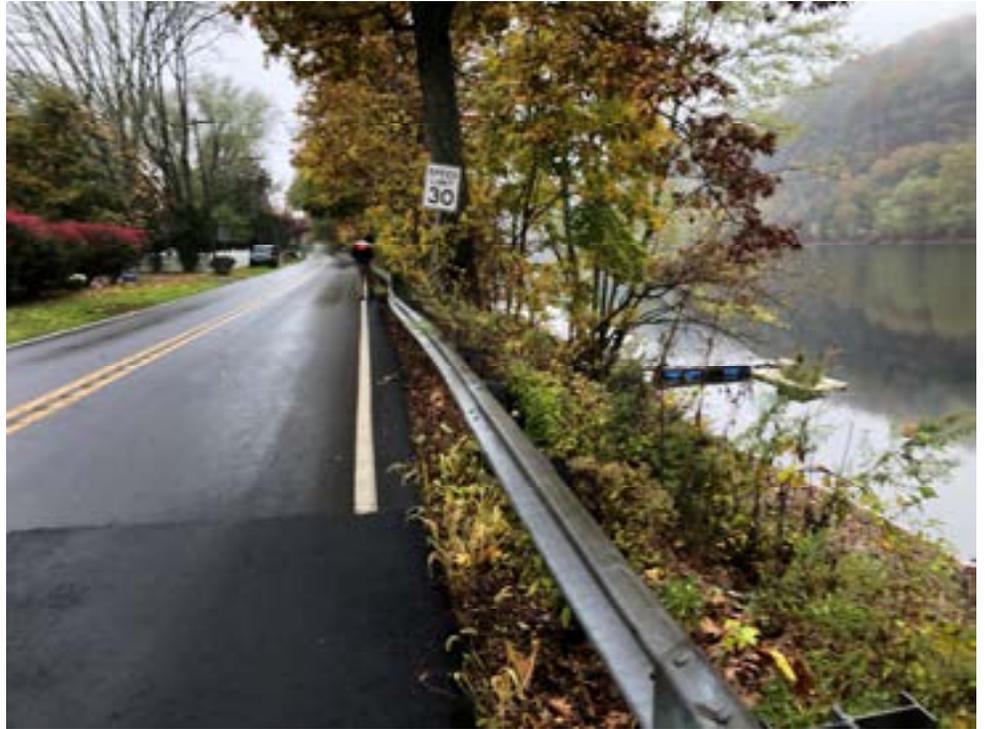
Located just to the north of the Bridgeton/Tinicum border, this AOC extends over a length of 350 feet with intermittent rills and gullies forming from stormwater running of as sheet flow from River Road. The gullies if left untreated could expose guardrail I-beams and rilling could cause tree fall and bank erosion. Typical Cross-Section C-C' was developed for the banks in this reach and is located in Appendix A.

- AOC#7 - This area is not actively eroding and does not show erosion warranting corrective measures at this time. RWE recommends monitoring this area in the future and utilizing one of the measures included in this study at such time that it is warranted.

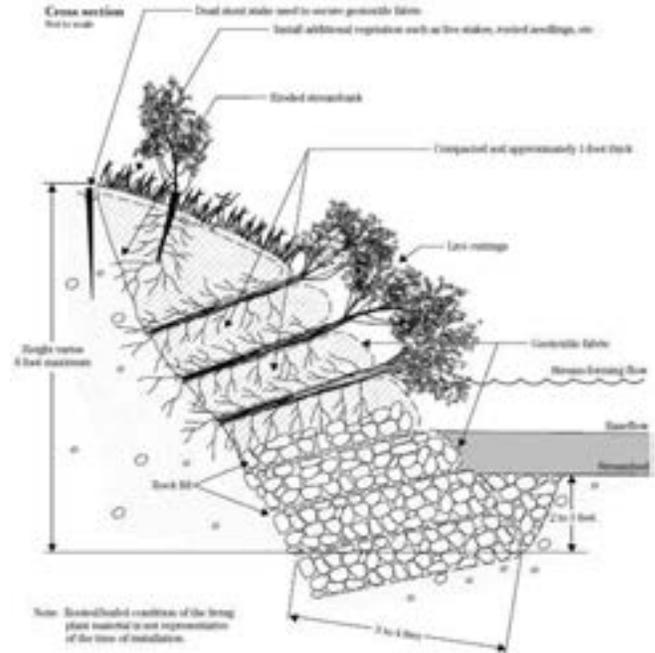
Vegetated Mechanically Stabilized Earth walls consist of alternating layers of live branches and compacted soil backfill to repair small, localized slumps and holes in streambanks. These are also known as vegetated geogrids and use natural or synthetic geotextile materials that are wrapped around each soil lift between the layers of live branch cuttings. VMSE walls can be constructed on slopes of 1H:1V or steeper. Soil lifts tend to be 12 to 18 inches in thickness.

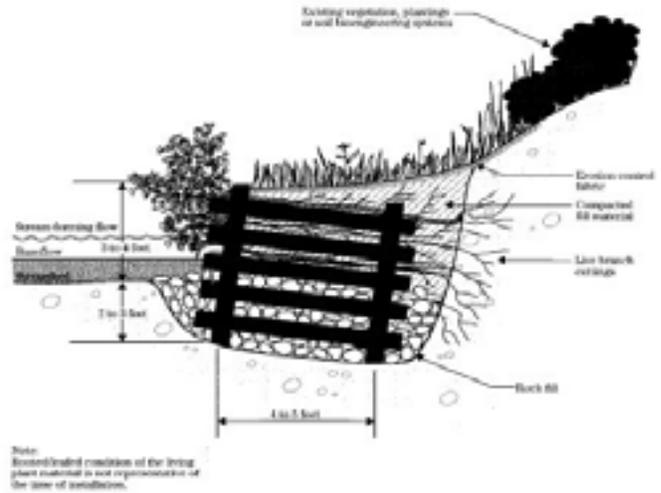
Figure 2. Typical timber crib wall detail (from USDA NRCS Engineering Handbook)

A timber cribwall consists of a box-like interlocking arrangement of untreated log or timber members. Once the live cuttings root and become established, the subsequent vegetation gradually takes over the structural functions of the wood members. Timber crib walls should be tilted back or battered if the system is built on a smooth, evenly sloped surface. These timber crib walls are appropriate to use at the base of a slope where a low wall may be required to stabilize the toe of the slope and reduce its steepness. These can be used in areas both above and below water where stable streambeds exist.

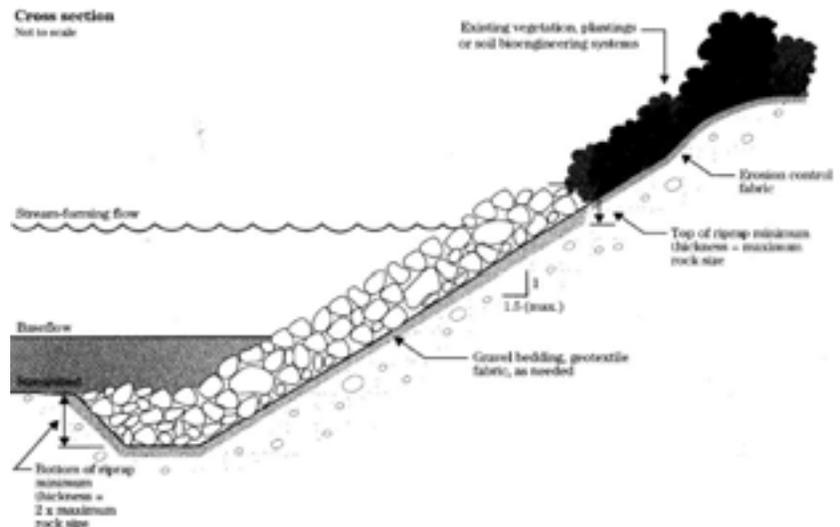
Figure 3. Typical detail of riprap slope (from USDA NRCS Engineering Handbook)

Rock riprap, properly designed and placed, can be an effective method of streambank protection, however, frequently the design or the installation of rock riprap is flawed, and the result is a significant failure of the bank. Riprap banks cannot be graded steeper than 1.5H:1V. Half dense riprap is a variation of the riprap bank stabilization technique that involves the placement of vegetation in gaps amongst the riprap to ensure some level of vegetative cover. Use of the half dense method offers the potential for a bioengineered solution that still achieves the stabilization that the riprap provides.

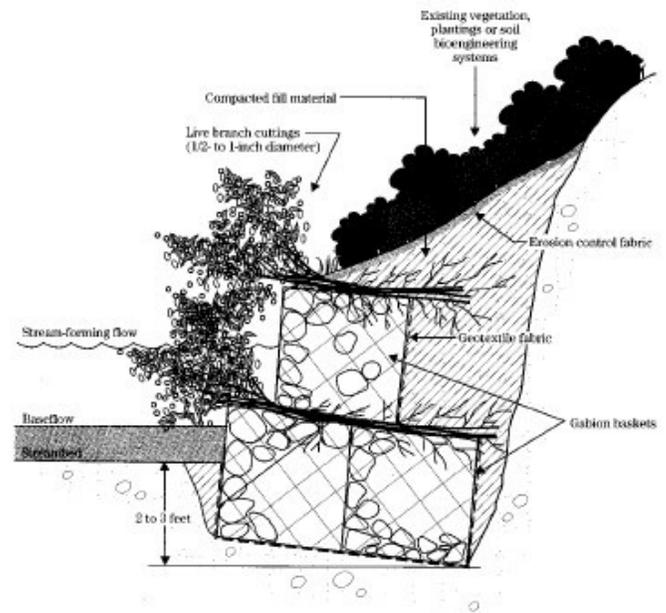
Figure 4. Typical gabion basket detail (from USDA NRCS Engineering Handbook)

Rock gabions consist of rectangular containers fabricated from a triple twisted, hexagonal mesh of heavily galvanized steel wire. Empty gabions are placed in position, wired to adjoining gabions, filled with stones, and then folded shut and wired at the ends and sides. Gabions can be used on steeper slopes (greater than 1.5H:1V) and are effective where the size of riprap is larger than can be reasonably sourced for the site. Vegetation can be incorporated into rock gabions, if desired, by placing live branches on each consecutive layer between the rock-filled baskets (fig. 15). These gabions take root inside the gabion baskets and in the soil behind the structures. In time the roots consolidate the structure and bind it to the slope.

Note:
Rooted/leafed condition of the living plant material is not representative of the time of installation.

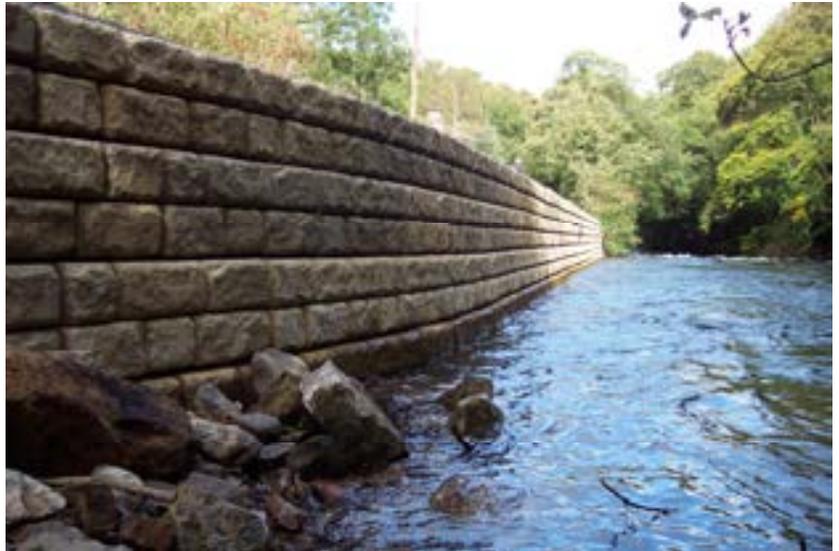
RWE considered the use of traditional retaining walls for the slope stabilization along the Delaware. Retaining walls are created to retain soils. This method can be used in stream channels of all types and sizes and is suitable for channels with widely fluctuating water levels and high velocities.

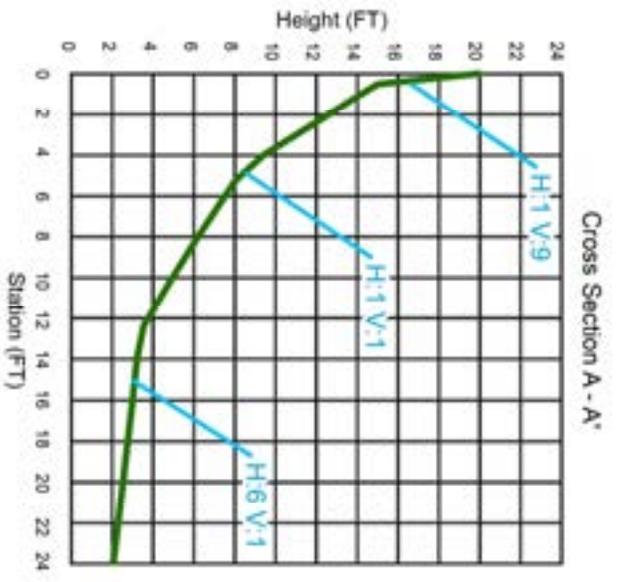
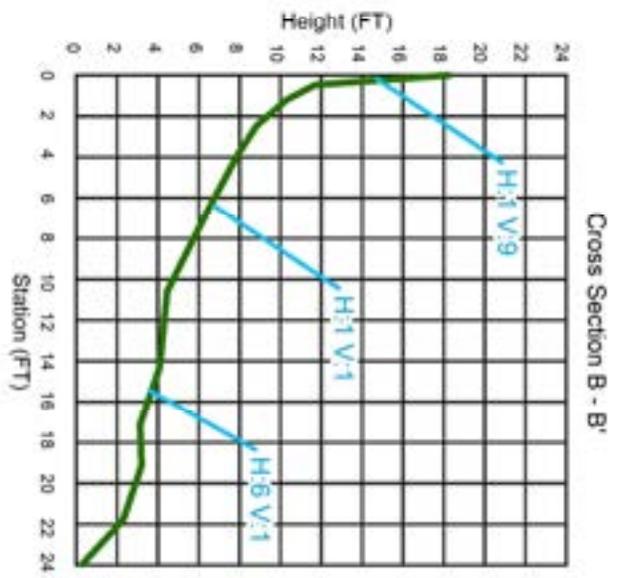
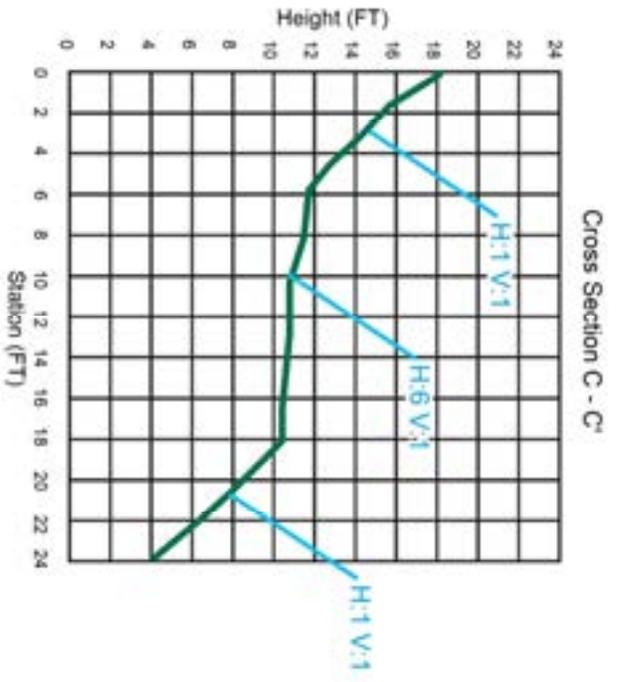
Delaware River Streambank Erosion Investigation,
 Bridgeton Township, Bucks County, Pennsylvania
 Cross Sections

Project Notes:
 1. Areas were noted and measured on October 5 & 28, 2020
 2. Site overview map calls out locations of cross sections.
